RubbaFIX[®]

CASE HISTORY

EDGE REPAIR

PLANT : Port Facility

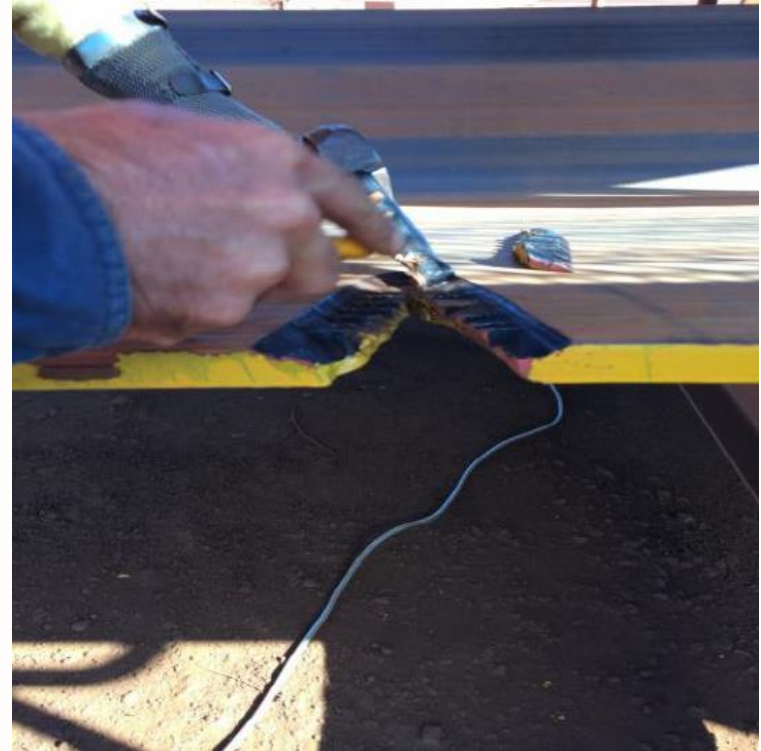
- Total repair time 2 hours using RubbaFIX®, including isolations.
- Repair usually done with hot press taking 6 hours.
- Edge damage measuring approximately 150mm wide, 30mm thick and 150mm towards centre of belt.
