RubbaFIX[®]

CASE HISTORY

GROOVE REPAIR

SUMMARY : 6 metre split repair

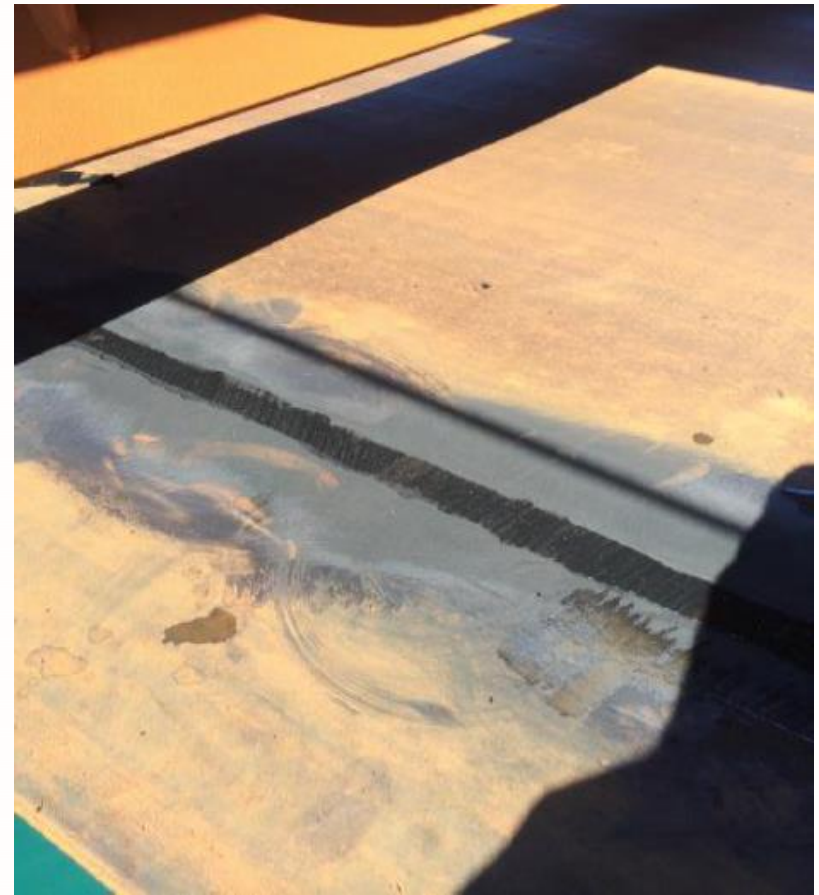
- **6 metre split in belt repaired.**
- **Belt returned to service in 1 hour.**
