# RubbaFIX<sup>®</sup>

## CASE HISTORY

PATCH REPAIRS

**PLANT** : Overland Conveyor

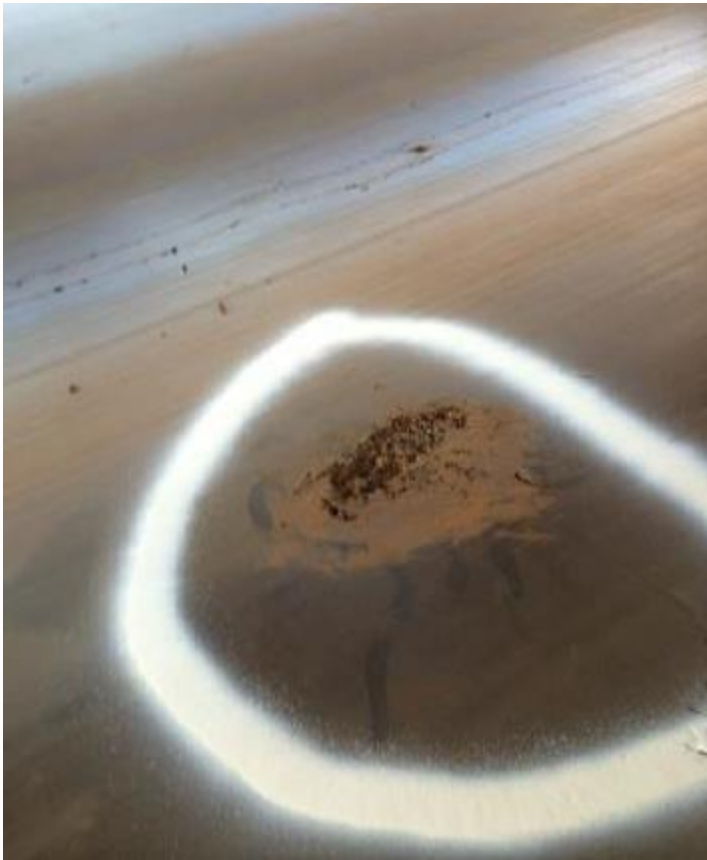
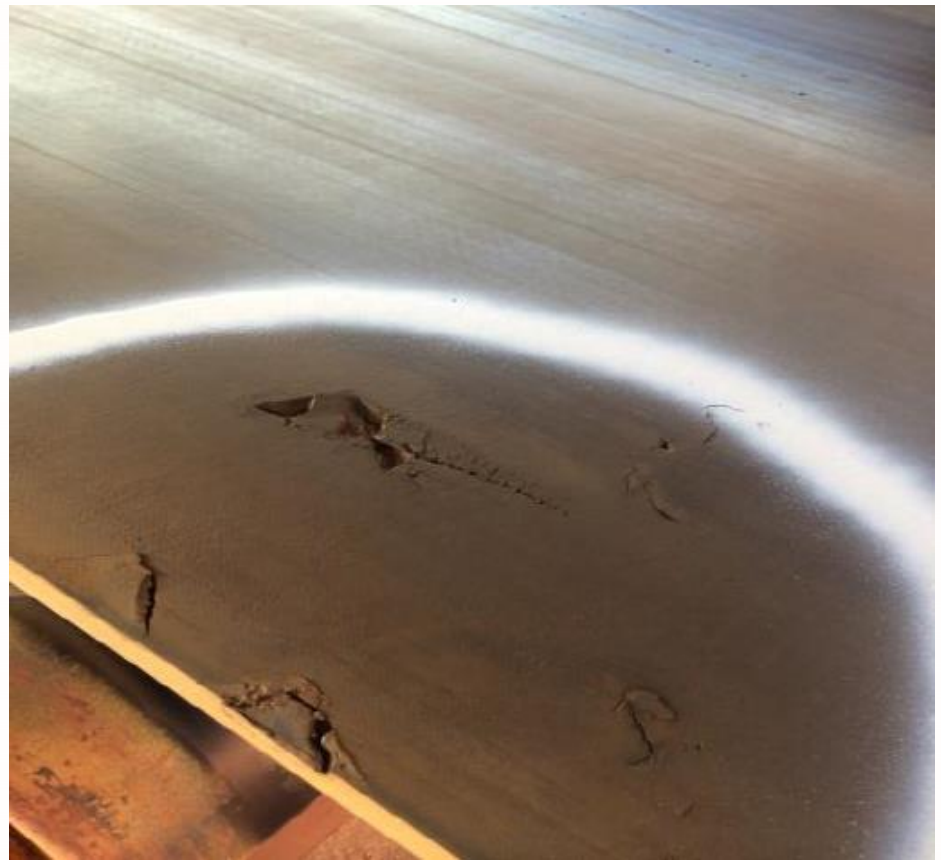
- Damage to bottom cover of conveyor belt.
