# RubbaFIX<sup>®</sup>

## CASE HISTORY

### PORT KEMBLA COAL TERMINAL SPLIT REPAIR

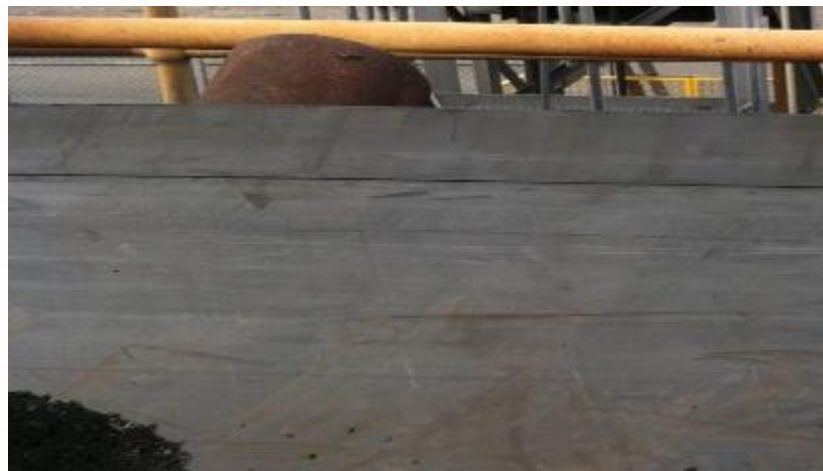
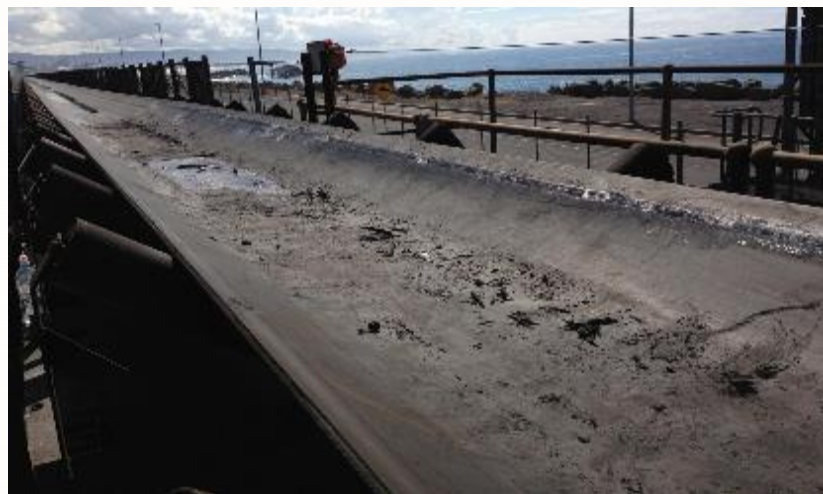
- **Roller malfunction on ship loading belt resulted in a 25 metre split through the entire thickness of the belt, causing shutdown of service.**
