RubbaFIX[®]

CASE HISTORY

Large Edge Repair

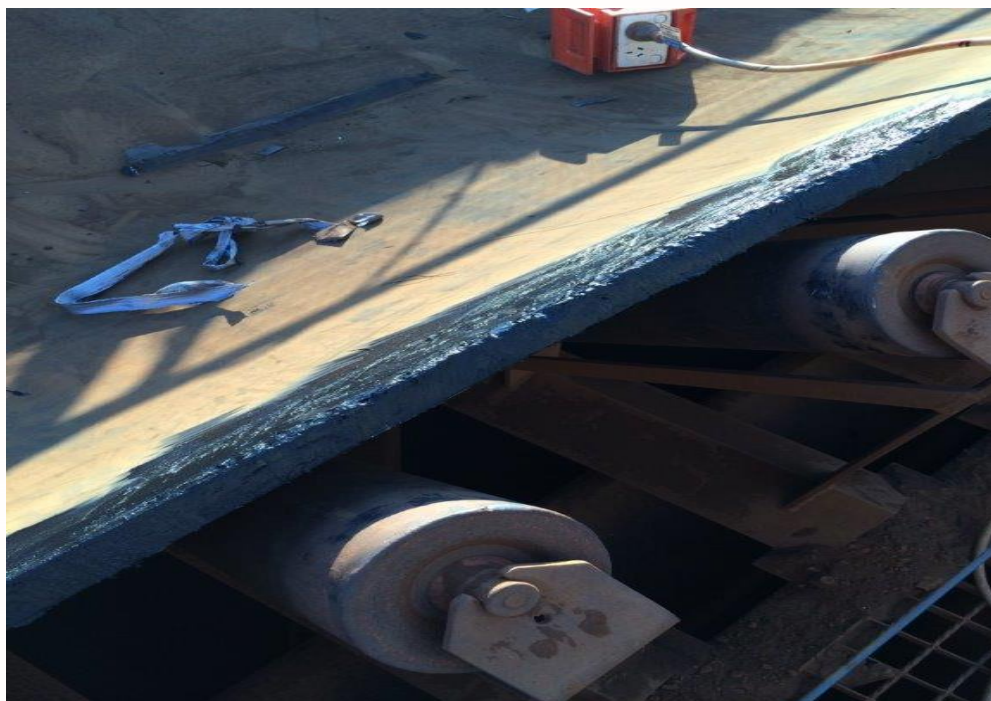
Damaged edge of conveyor belt successfully repaired and rebuilt using RubbaFIX®.

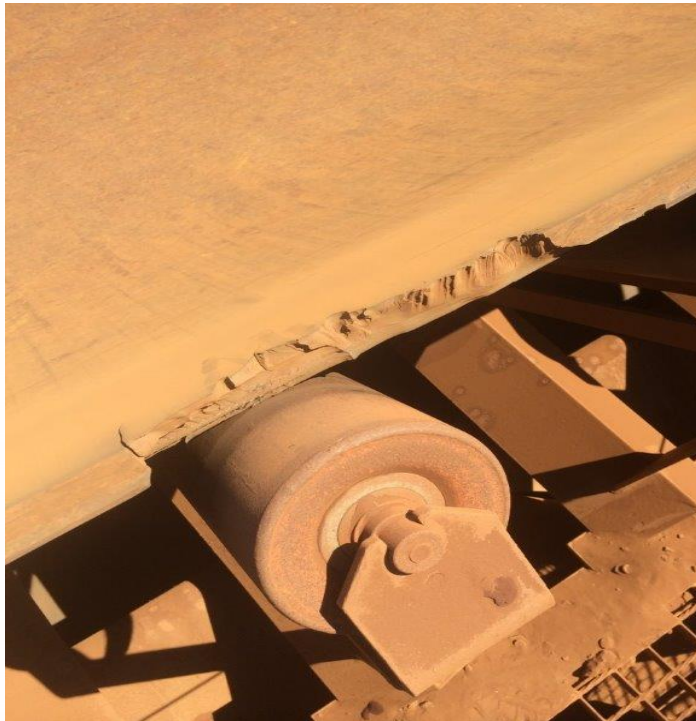
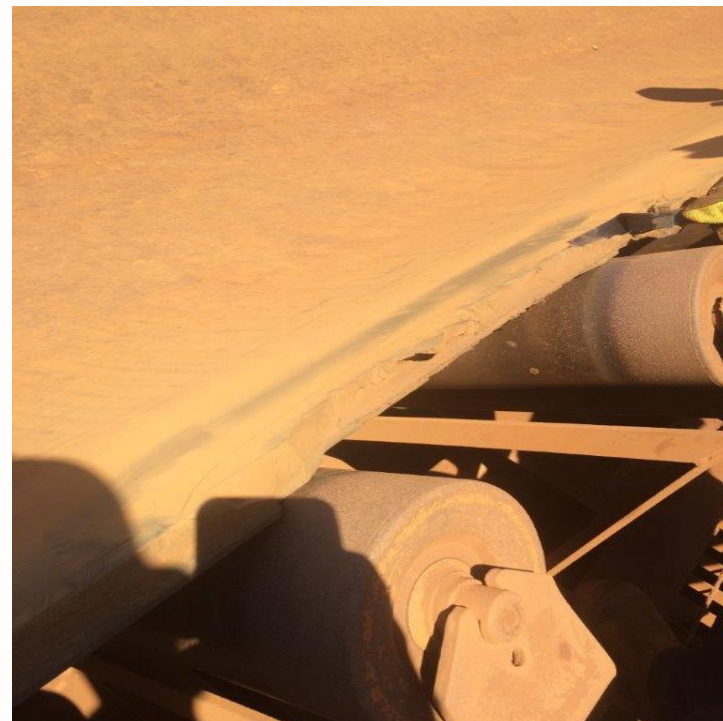
Belt tracking caused damage to the edge of the conveyor belt.
