CASE HISTORY

ROM FEEDER CONVEYOR BELT PATCH REPAIRS

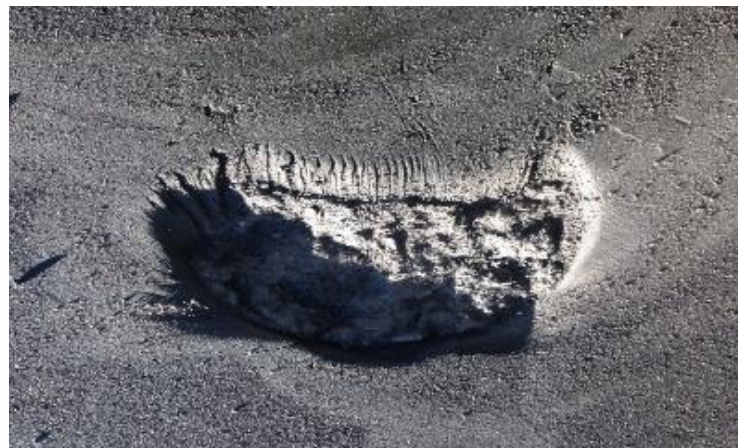
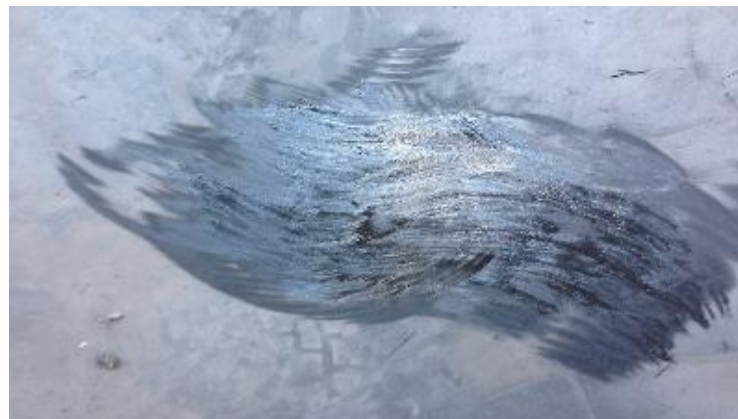
ROM feeder conveyor belt suffering from multiple divots in top cover due to large, high-impact rock falling through the chute from the haul truck. Divots then filled with coal particles.

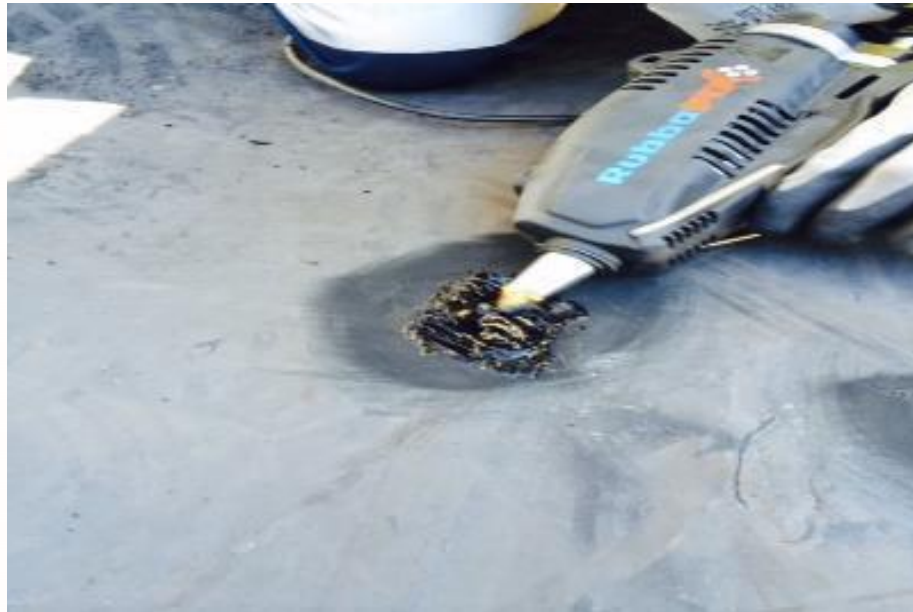
RubbaFIX® left to set for 30 minutes then buffed back flush with top cover to avoid scraper contact.

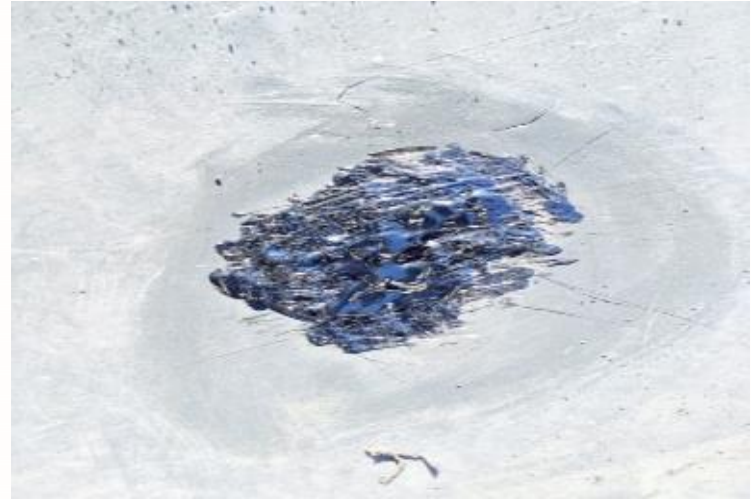
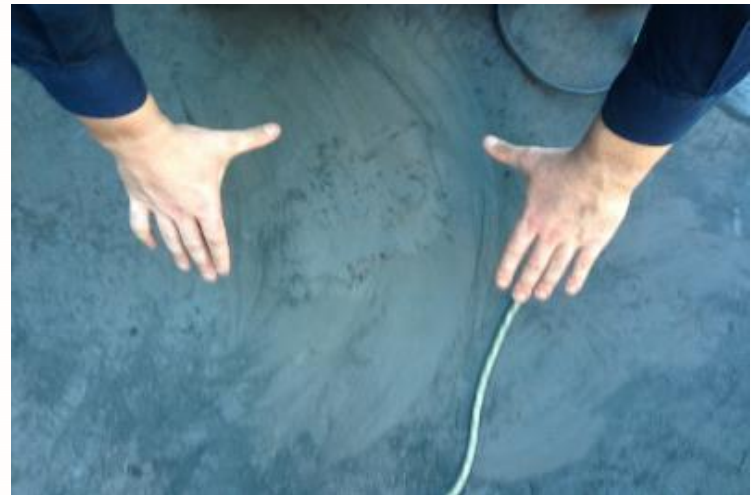
Repairs advised to have outlasted previously used two-part compounds.

(Photo to the right shows repair after belt was returned to service.)
