# RubbaFIX<sup>®</sup>

## CASE HISTORY

### PORT KEMBLA COAL TERMINAL SPLIT REPAIR

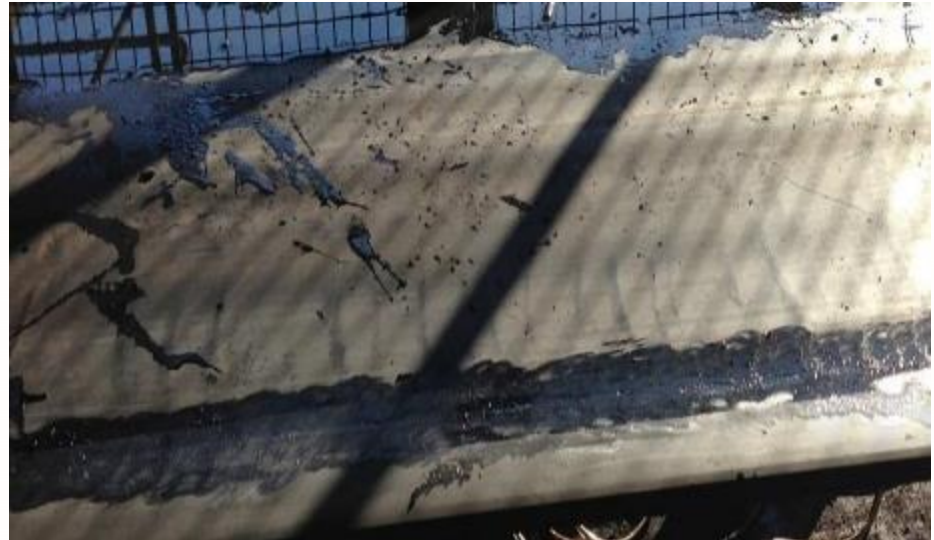
**SUMMARY** : 25 metre cut through entire thickness of belt, to be repaired on both sides.

- Conveyor was then rotated so that the underside could be repaired.
- Process of repair on the underside of the belt was identical to that of the top cover, before returning to service.
